2019 BMW 540i Sedan (G30) L6-3.0L Turbo (B58M)

RELEASING THE OIL FILTER COVER [REP-TAT-P-1142-01-G11\_1]

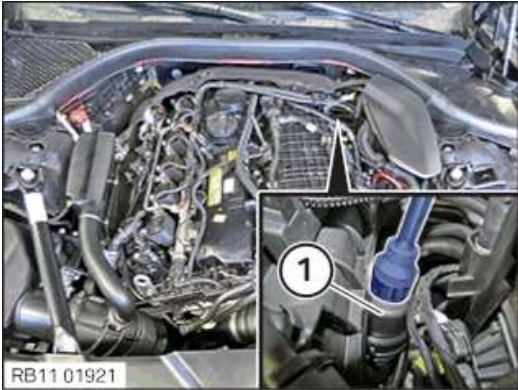
REP-TAT-P-1142-01-G11\_1

- Loosen the oil filter cover (1).
