2013 BMW 320i Sedan (F30) L4-2.0L Turbo (N20)

REMOVING AND INSTALLING/RENEWING ACOUSTIC COVER (N20) [REP-REP-RAF3011N20-1112090]

### 11 12 090 Removing and installing/renewing acoustic cover (N20)

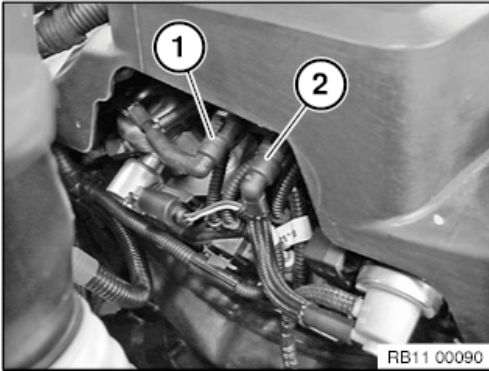
Unlock and pull off vacuum connections (1) and (2) from vacuum accumulator.

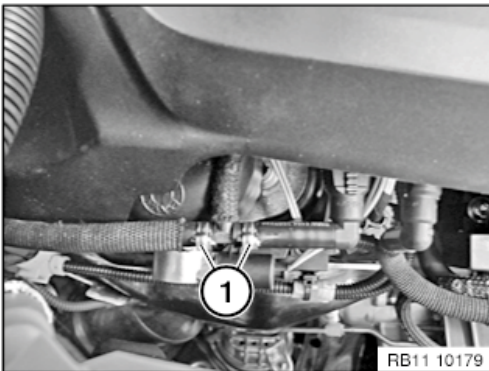
If the hose clips (1) are not installed, they must be retrofitted.

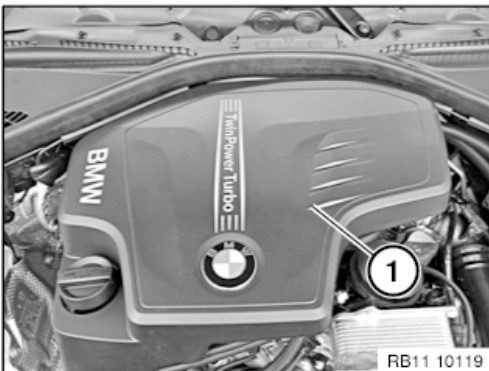
Remove acoustic cover (1) in following steps:

- Lift up in the front area.
- Pull out from rear rubber guide in direction of travel.

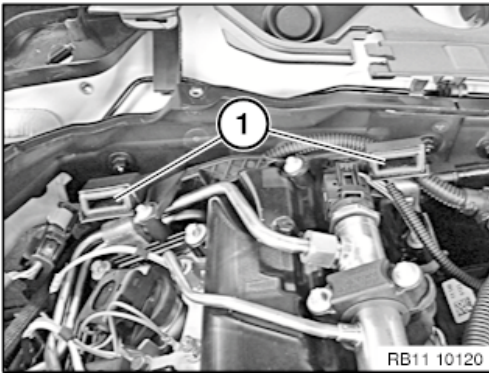
**Installation note:**

Insert acoustic cover into existing rubber mounts.

For a better overview, image shows bulkhead sound insulation removed.
