2013 BMW 320i Sedan (F30) L4-2.0L Turbo (N20)

## REPLACING IGNITION COILS (N20,N26) [REP-REP-RAF3012N20-1213511]

#### 12 13 011 Replacing ignition coils (N20,N26)

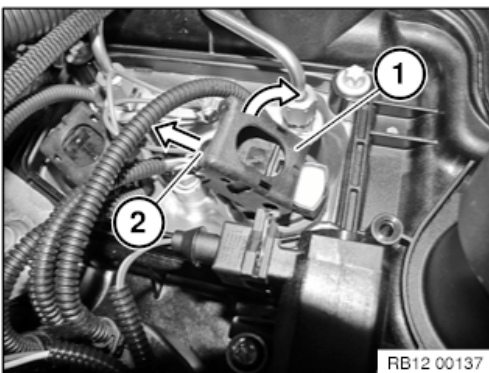
Unlock plug catch (1) of ignition coil (2) and disconnect plug.

Ensure that cables are not crushed or damaged.

Repair damaged cable.

Pull ignition coil (2) up and out.

**Note:** There is a possibility that the silicone tube will tear and therefore be destroyed.

This procedure is applicable to all ignition coils.

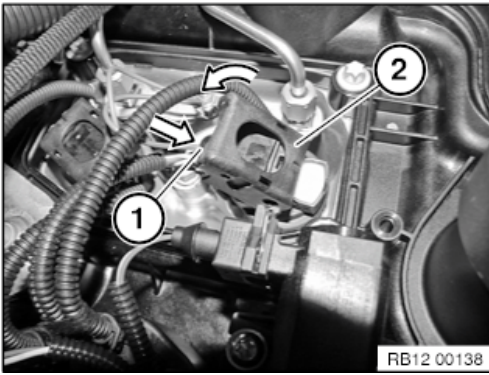
**Installation note:**

Position the ignition coil and gently push it to the limit position, if necessary by twisting it back and forth slightly. Then check anti-twist lock.

The rubber cap must completely surround the sealing collar of the cylinder head cover.

**Note:** If rubber parts are squashed, the ignition coil can slip out again during engine operation.

Push connector (1) with connector catch (2) open onto ignition coil.

Carefully close connector catch (2) in direction of arrow.

Ensure that cables are not crushed or damaged.

Repair damaged cable.

**Note:** The locking lever can become deformed if it is not installed correctly. This means that there is no longer a safety lock on the plug connection. As a result, the connector can slip out during engine operation (loose contact, misfiring).
