2019 BMW 330i Sedan (G20) L4-2.0L Turbo (B46D)

PERFORM THE CBS RESET [REP-TAT-P-0000-23-7]

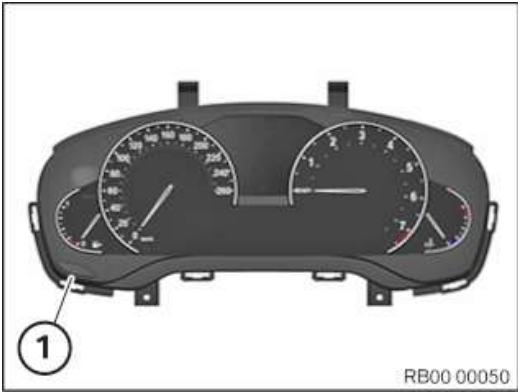
• **Equipment specification with the reset button for the trip odometer in the instrument cluster (KOMBI)**

Generate PWF status "Residing".  
Generate PWF status "PAD": For this purpose, press the START-STOP button three times.  
Press trip distance recorder reset button (1) for approx. 10 s, until the 1st maintenance work appears on the display.  
The next position is reached by briefly pressing the trip distance recorder reset button (1) again.  
Select the desired service job.  
If a CBS reset is possible, "Reset possible" is displayed in the instrument cluster (KOMBI).  
Confirm the "Perform reset?" text message. In addition, press the trip distance recorder reset button (1) for 3 s.  
The CBS reset is confirmed as "Reset successful" after completion.
