2019 BMW 330i xDrive Sedan (G20) L4-2.0L Turbo (B46D)  
Vehicle > Engine, Cooling and Exhaust > Engine > Engine Lubrication > Oil Filter > Service and Repair > Removal and Replacement  
REMOVING THE ACOUSTIC COVER [REP-TAT-P-1112-01-G20\_B48]

Removing the acoustic cover

REP-TAT-P-1112-01-G20\_B48

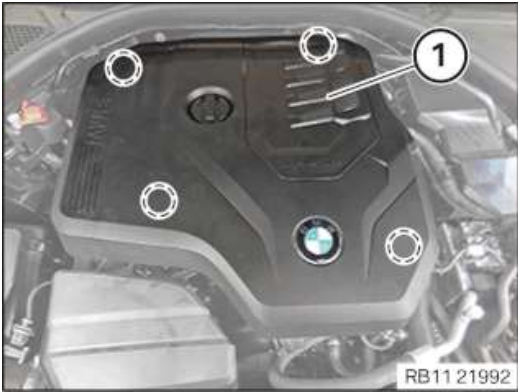
- Unclip acoustic cover (1) upwards from the holders in the **marked** areas.
