2019 BMW X2 xDrive 28i AWD (F39) L4-2.0L Turbo (B46O)  
Vehicle > Engine, Cooling and Exhaust > Engine > Engine Lubrication > Service and Repair > Procedures

CLOSING THE SERVICE FLAP IN THE FRONT UNDERBODY PROTECTION [REP-TAT-P-5147-07-F46\_B38]

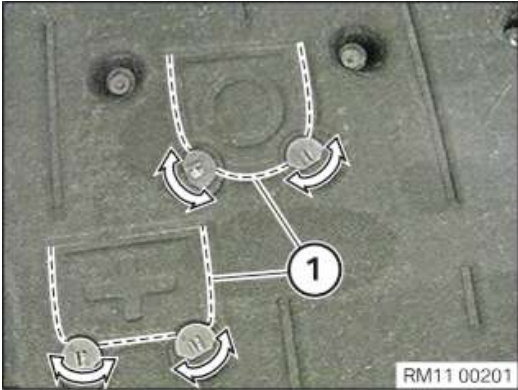
REP-TAT-P-5147-07-F46\_B38

- Close the service flaps (1) in the front underbody protection in the arrow direction.
